**RE: Performance-Based Work Plan for
PCB-Containing Caulk and Window Glazing
Associated with Additions & Alterations to
Stadley Rough Elementary School
25 Karen Road
Danbury, Connecticut**

Self-Implementing Plan for On-Site Cleanup and Disposal of PCB Caulking Associated with Additions and Alterations to

Stadley Rough Elementary School
25 Karen Road
Danbury, Connecticut

LIMITED PCB TESTING OF CAULK AND PUTTY ASSOCIATED WITH

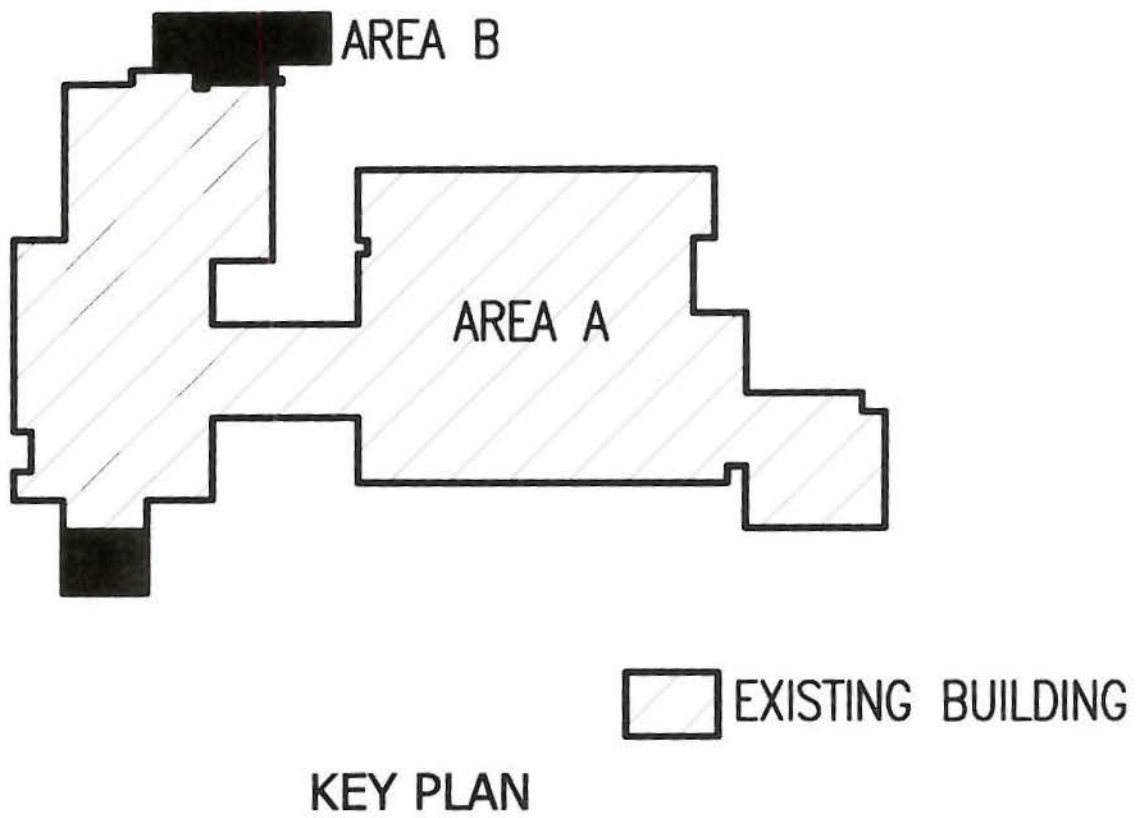
FIGURE 2

The inspection scope was determined by meetings with Kaestle Boos Associates, Inc., project architects on November 28, 2012 and January 29, 2013. It was determined that the scope of work with respect to possible PCB-containing caulk and putty is limited to one classroom window unit, one exterior door, and the cafeteria exterior windows. Figure 2 shows the construction key plan.
